192FARM ENVIRONMENT PLAN

Owners: Dick & Gaylene Brough
238 Republican Road
Rerewhakaaitu

Report prepared by
Perrin Ag Consultants, Rotorua
Rachael Mitchell, CNMA

18 December 2017

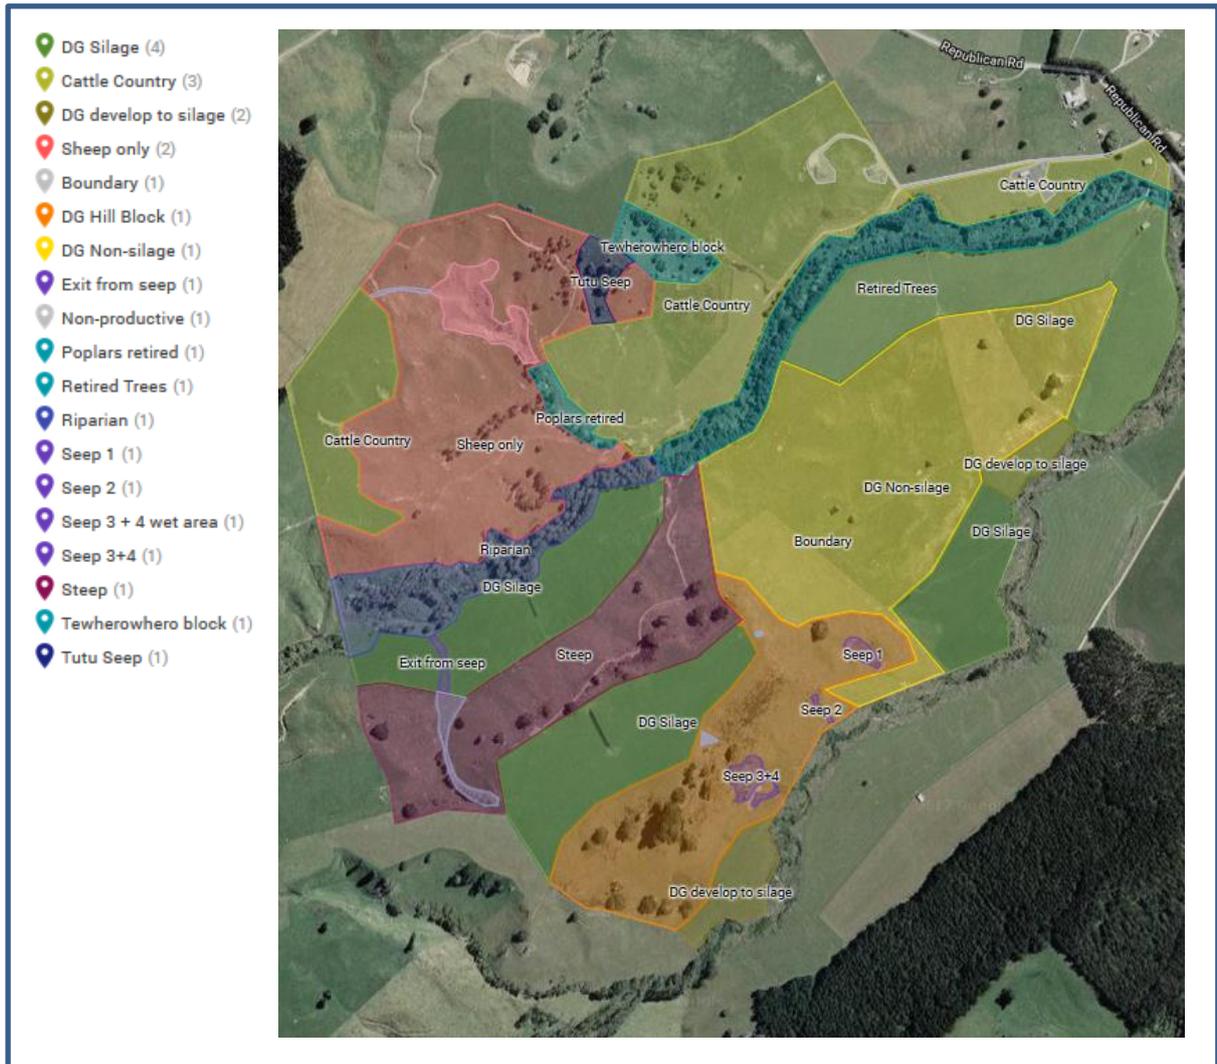
Figure 1: Block Map of 238 Republican Road, Rerewhakaaitu

- 5.5. The farm has been mapped as two distinct activities, reflecting the way it is currently run and the fact that the southern block is the more productive part of the farm.

- 5.6. The farm map, identifying the mapped blocks is in Figure 1 overleaf:

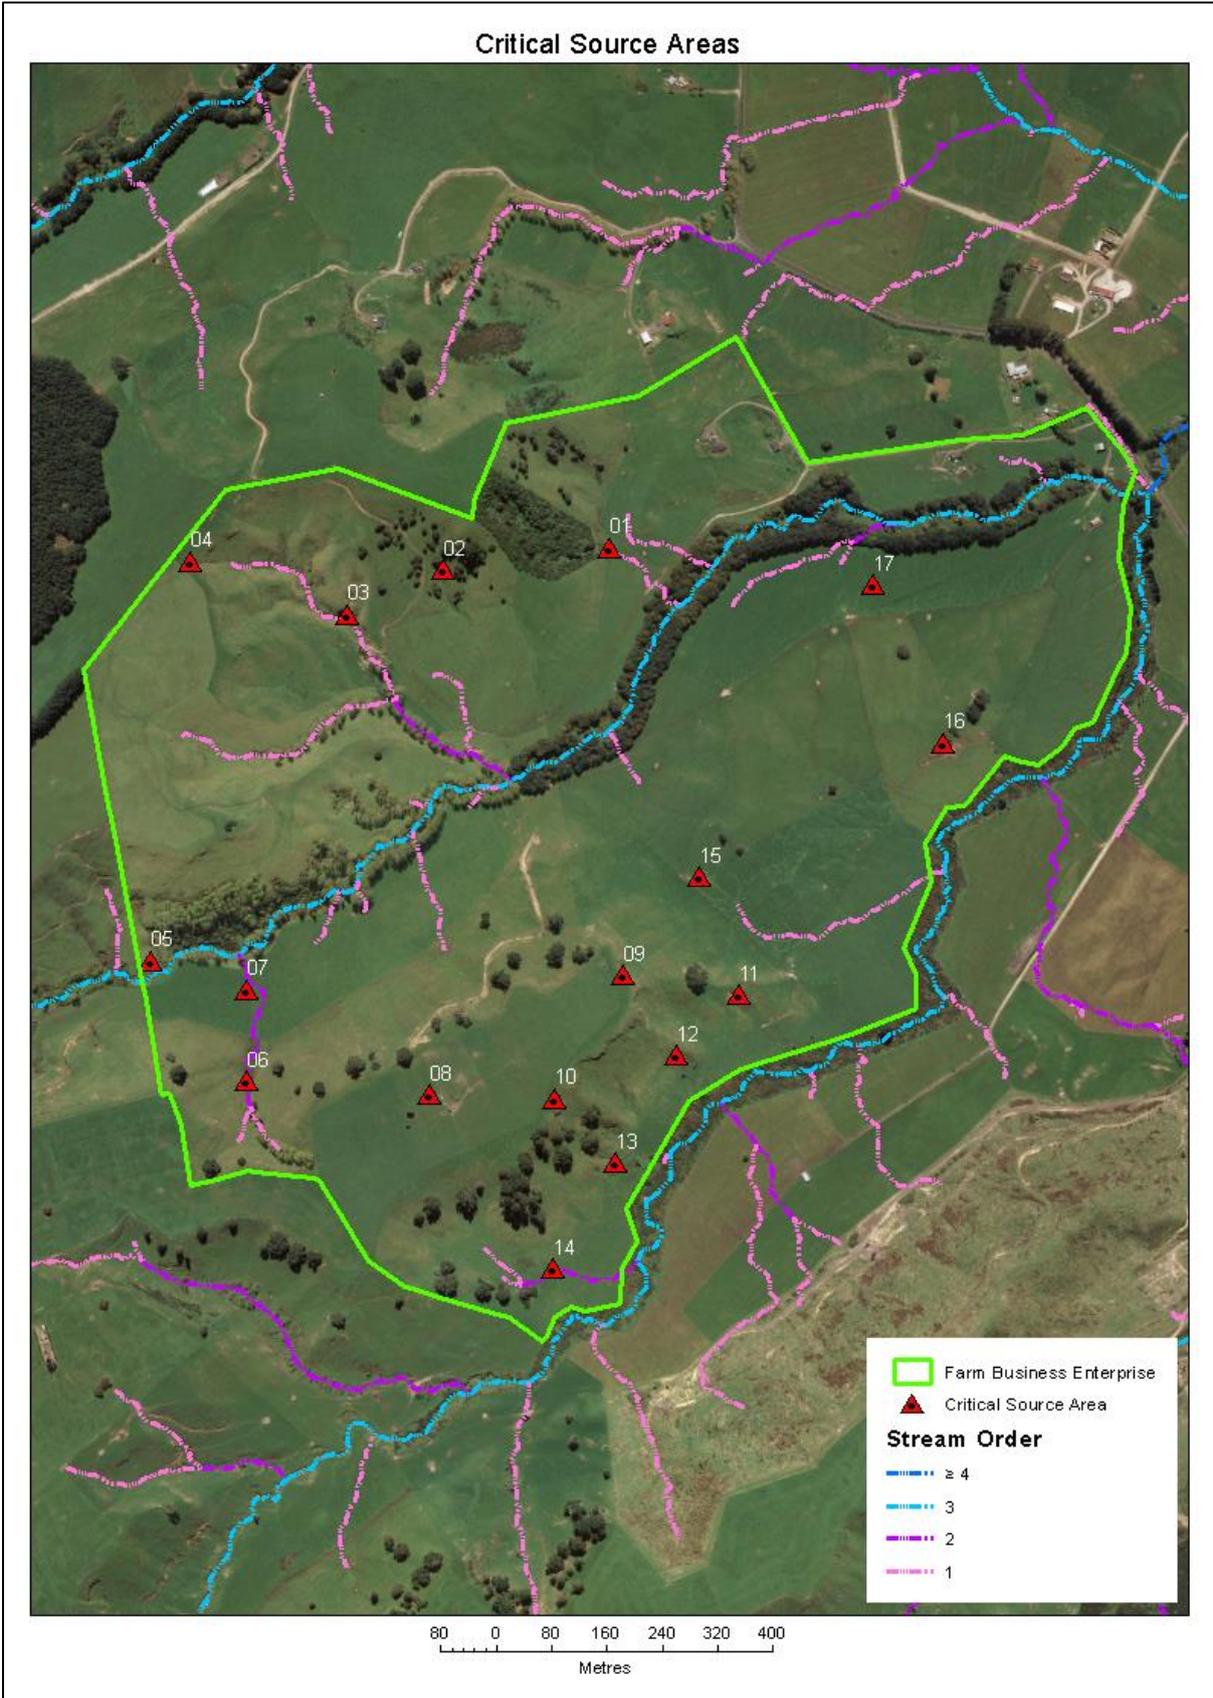
Figure 2: Map of CSAs for 238 Republican Road, Rerewhakaaitu

- 2.1. Critical Source Areas (CSAs) are identified below, and numbered consecutively on the Land Management Map (Figure 2). Accompanying photos are attached in Appendix 1 and labelled referring their relevant CSA.
- 2.2. A checklist summary of the CSAs and their priority is in Table 1, to allow for easy monitoring of progress.
- 2.3. A high-level documentation of each CSA is in the following table, Table 2, overleaf
- 2.4. Where poplar poles are suggested for planting, refer to Plant & Food Research 'Trees for the Farm' leaflet

5.7. The map of Critical Source Areas (CSA), discussed in section 9, is in Figure 2, overleaf:

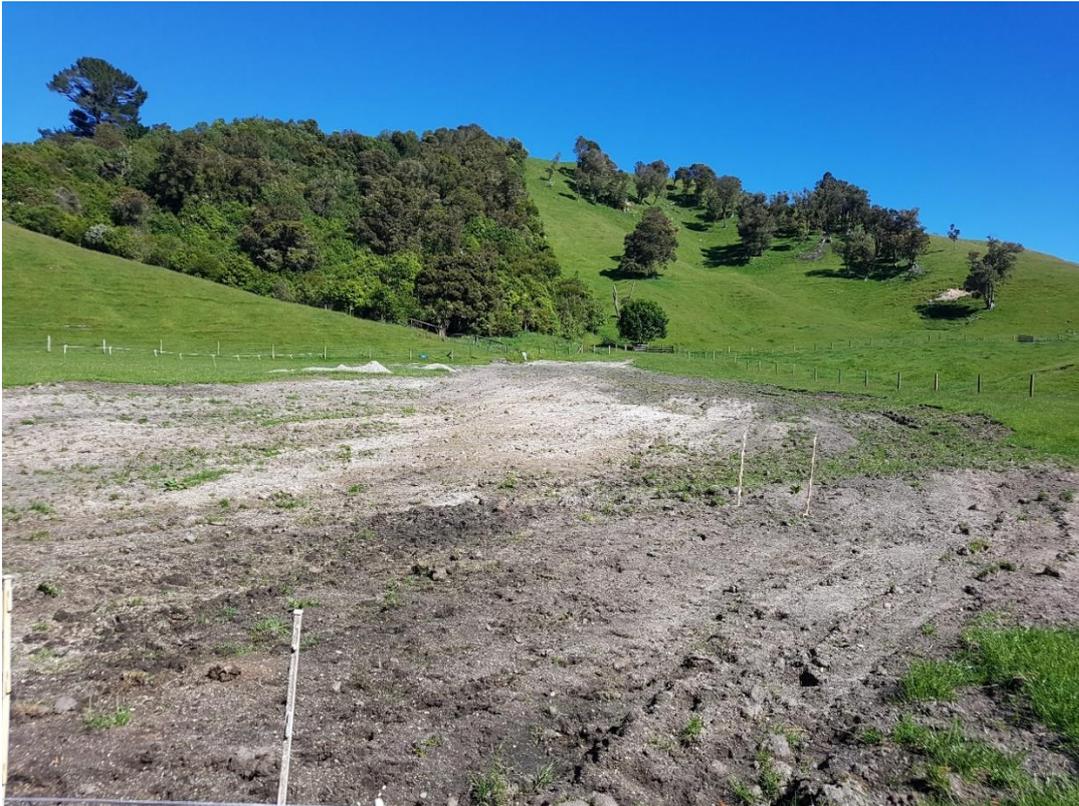
CSA	Issue	Mitigation	Timeframe	Benefits
1	Seep from retired trees running through paddock	<ul style="list-style-type: none"> • Create small duck pond where seep leaves bush, novaflow below and then recontour a meandering flow path. Exclude stock while pasture is re-established 	Current	<ul style="list-style-type: none"> • Duck shooting dam • Water protected to exit point at stock excluded creek • Retain in effective area, increasing productivity of an historically wet area
2	Tutu Seep with receding gully head, and water flowing through paddock	<ul style="list-style-type: none"> • Fence around seep and accompanying water way, down to southerly fence <ul style="list-style-type: none"> ○ Retirement fence to extend to take in steepest contour and large proportion of remnant Tewherowhero trees. ○ Remaining paddock will be cattle in summer only, sheep all year round. ○ Remove Tutu and replant with natives. 	Jul 2020	<ul style="list-style-type: none"> • Prevent seep creeping up hill face • Prevent edges of seep exit being further broken down and eroding • Protect water course (goes underground after retirement area) • Opportunity to increase native retired/ regeneration area • Summer grazing for cattle with shade

Image 1: CSA 1, novaflowed seep exit, re-contoured and re-grassed

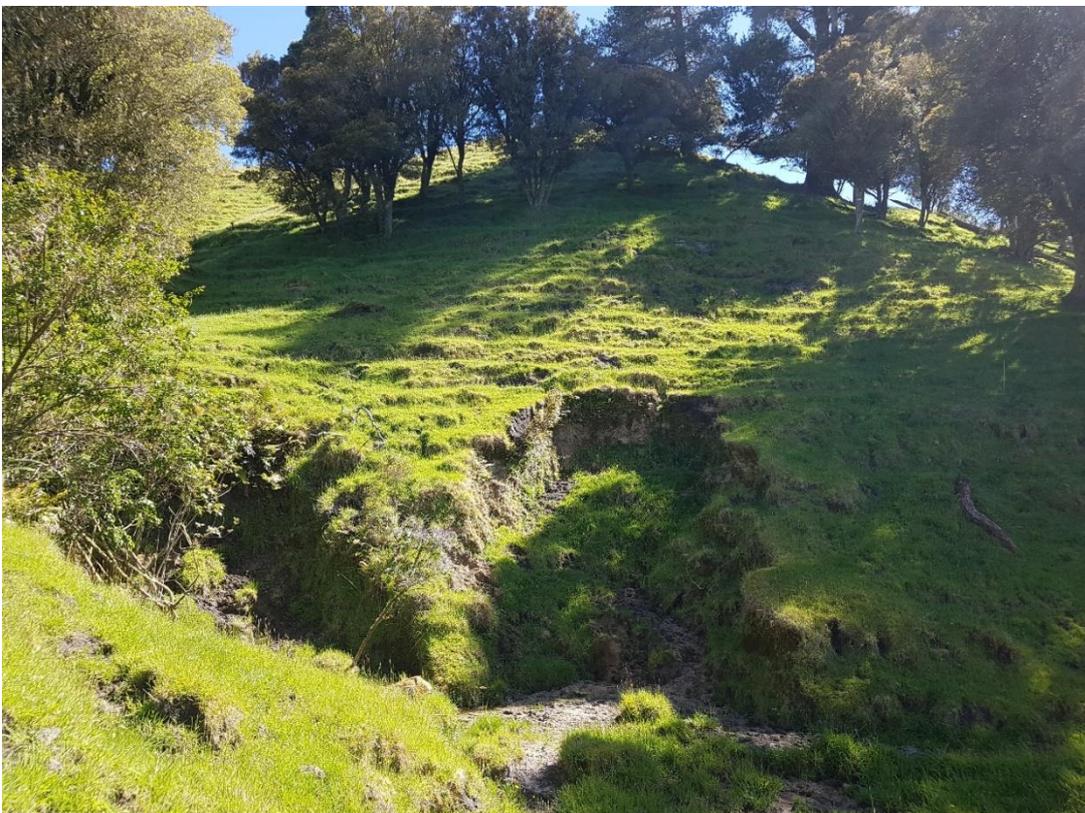
Image 2: CSA 2, 'Tutu Seep' to be retired and replanted

High	Date	X	Medium	Date	X	Low	Date	X
CSA 3 Wet Stream head	Jul-20		CSA 2 Tutu Seep	Jul-20		CSA 6 Remove old poplars	Jul-20	
CSA 4 Gully erosion	Jul-20		CSA 11 Perm fence seep	Jul-22		CSA 12 Perm fence seep	Jul-24	
CSA 5 Riparian at creek	Jul-19		CSA 13 Perm fence seep	Jul-22				
CSA 6 New poplar poles	Jul-19		CSA 15 Move trough	Jul-18				
CSA 9 & 10 New poplar poles	Jul-19		CSA 11-13 Reticulate water	Jul-20
